**VIOLET & VICTOR CLARK  
HOUSE FIRE  
623 School Street  
Carrollton, Illinois  
NOVEMBER 1950**

In November 1950 power went out on School Street and as the weather was cold Victor Clark started a fire in a newly constructed fireplace located along the east wall of the living room. Victor and Violet had remodeled and had the fire place installed in the home.

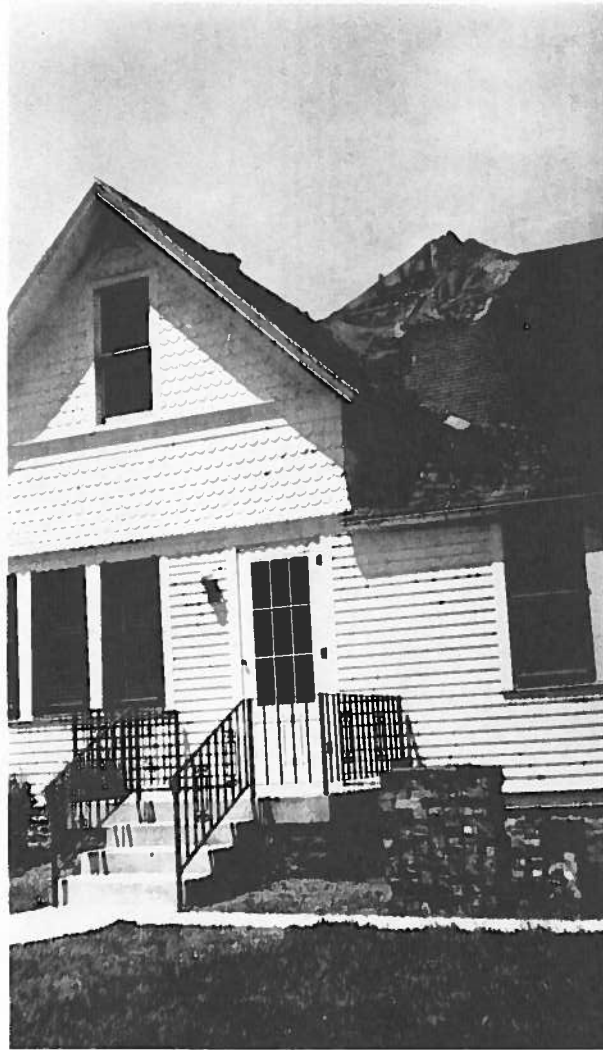
**South (front) side of the house. Fire broke through  
the roof in the center of the house**

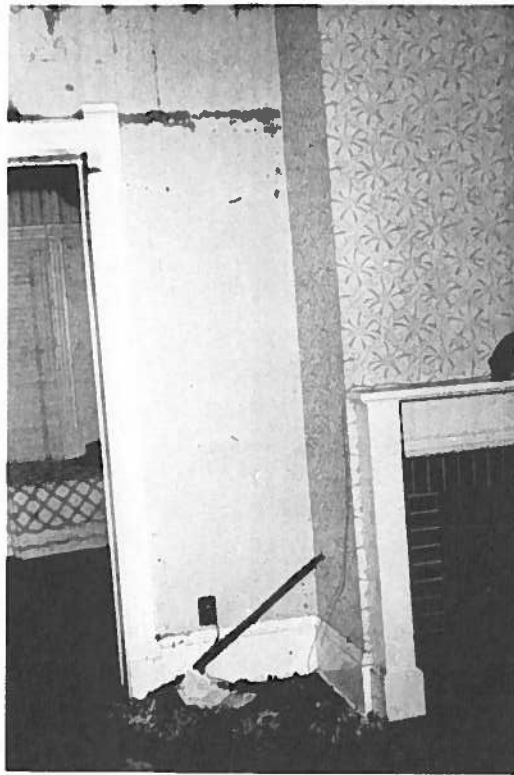
Unknown to Victor a brick was left out of the burn chamber or brick chimney when constructed. When the fire was started in the fire place, fire quickly burned through the plaster or mortared spot in the fire place and spread up the inside wall between the living room and a guest bedroom east of the living room.

**East wall of the living room. Fire place on right and doorway  
Into a bedroom east of the living room.**

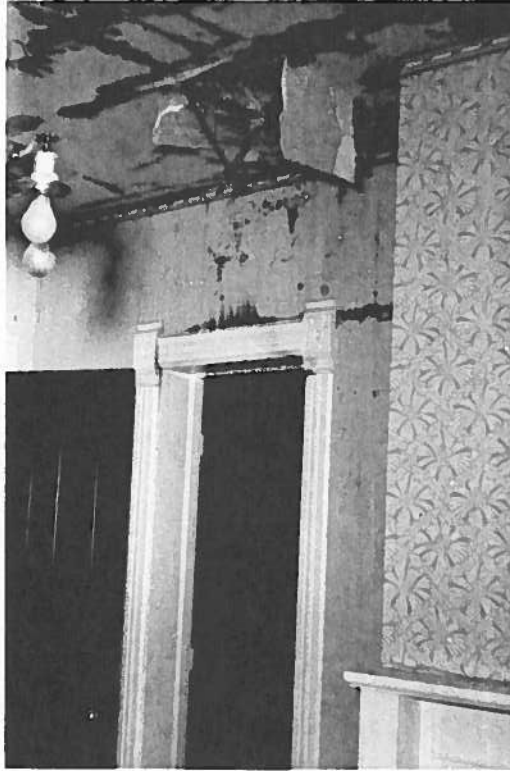
**East wall of the living room. Fire place on right and doorway  
Into a bedroom east of the living room.**

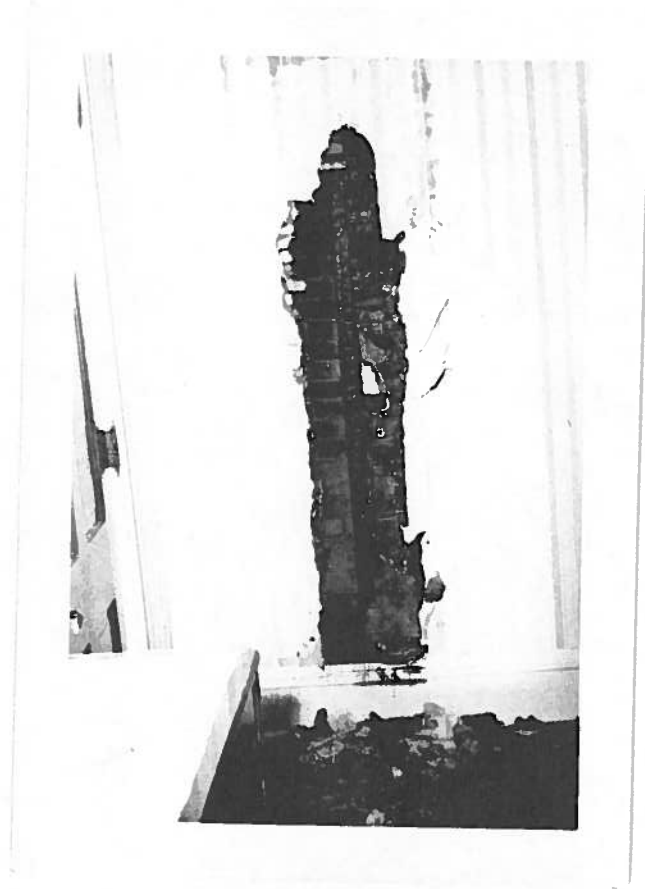
**West wall of the bedroom behind the fire place.  
Fire traveled up the inside of the wall into the attic.**

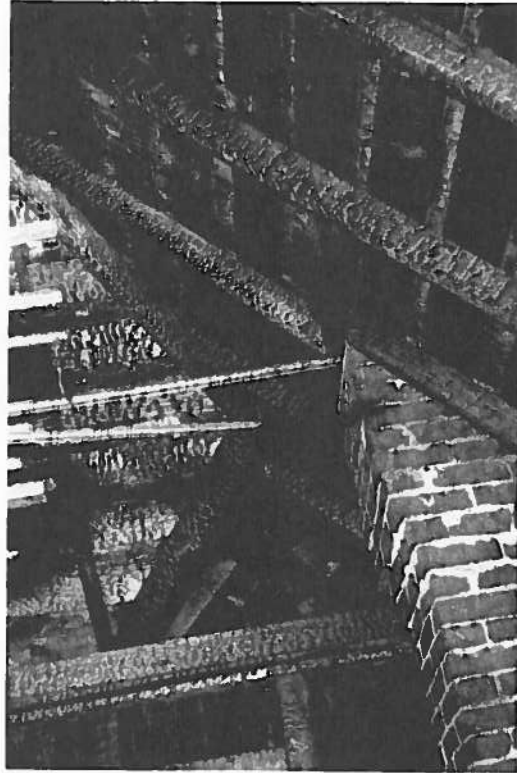
**Chimney at the roof line in the attic.  
Note the heavy charring of the roof rafters.**

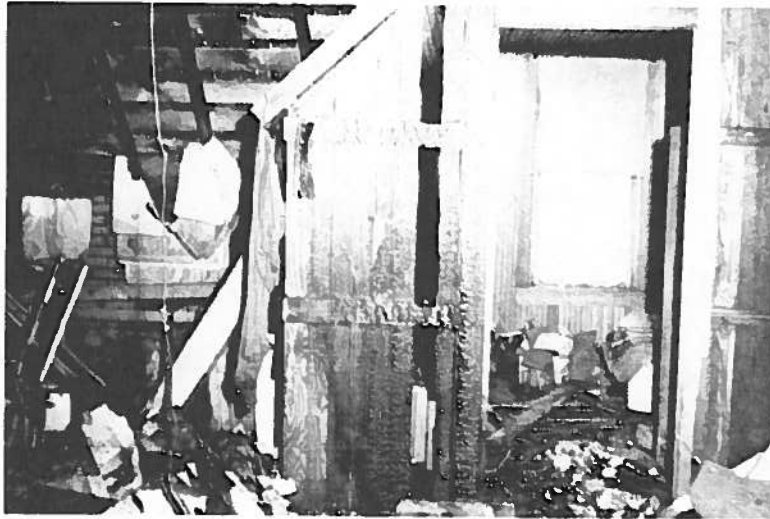
**Attic area above the living room and fire place.**

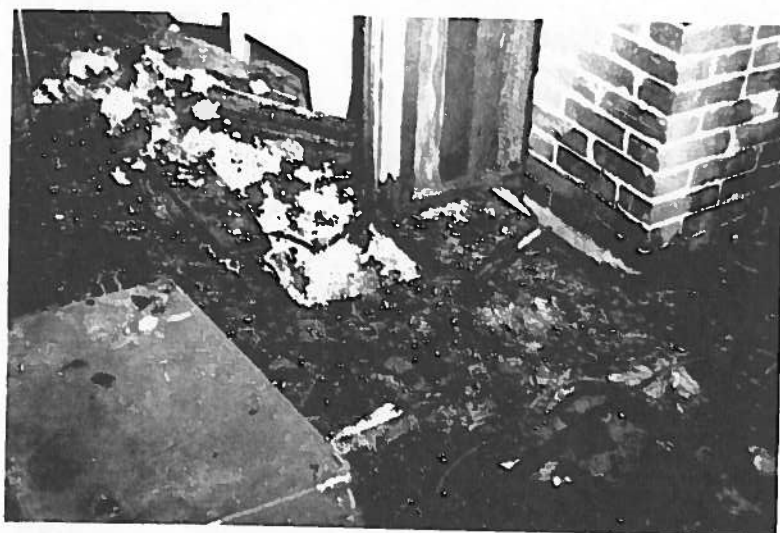
**Fire place chimney at floor level in  
The center of the attic**

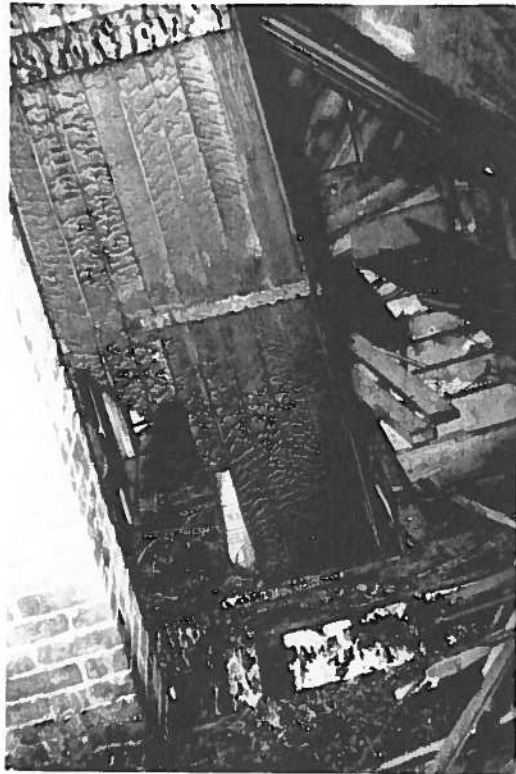
**Backside of the fire place chimney at floor level in the attic.  
Note the heavy burning where fire traveled up the inside  
Of the wall and burned through the attic subfloor.**

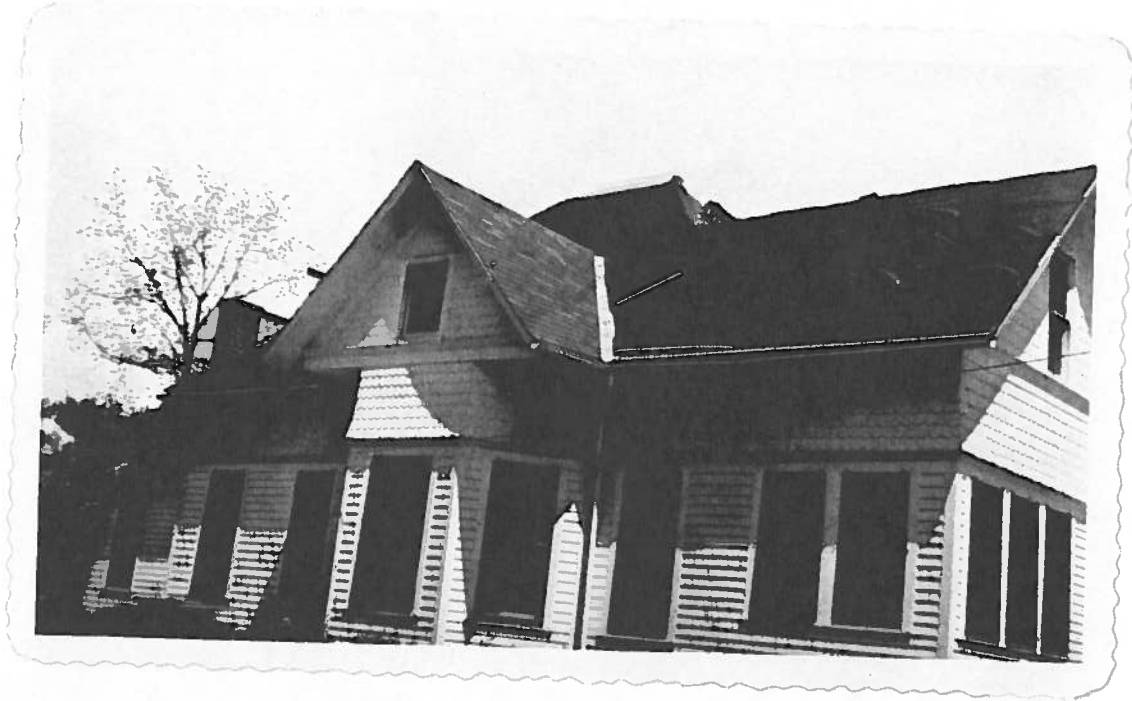
**West side of the house during the repair process after the fire.**

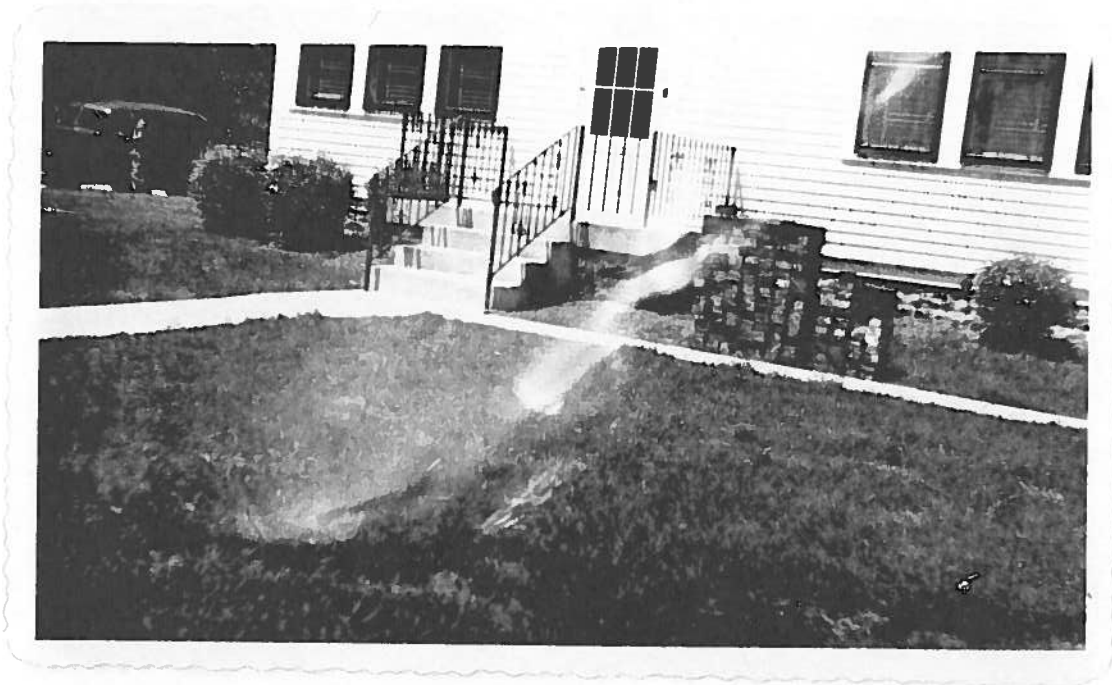
**South side of the house during the repair process after the fire.  
New bricks stacked in the front yard for the new fire place  
In the living room of the home.**

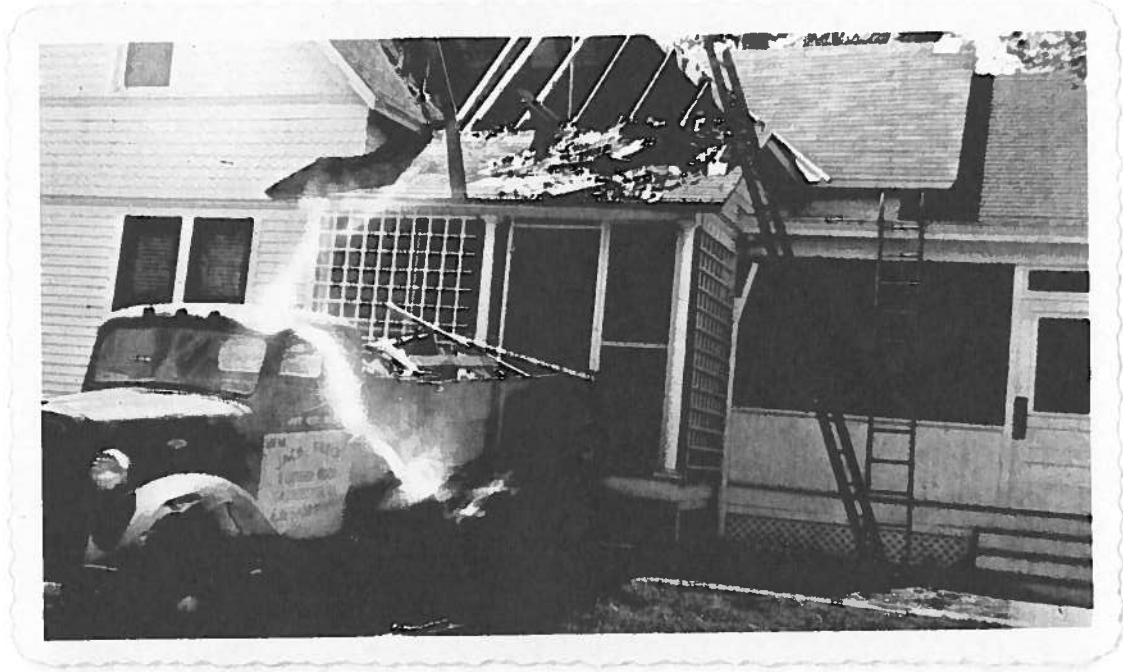
**East side of the house during the repair process after the fire.  
Shows fire debris from the attic being load from above  
the screened in porch south of the rear door of the home.**

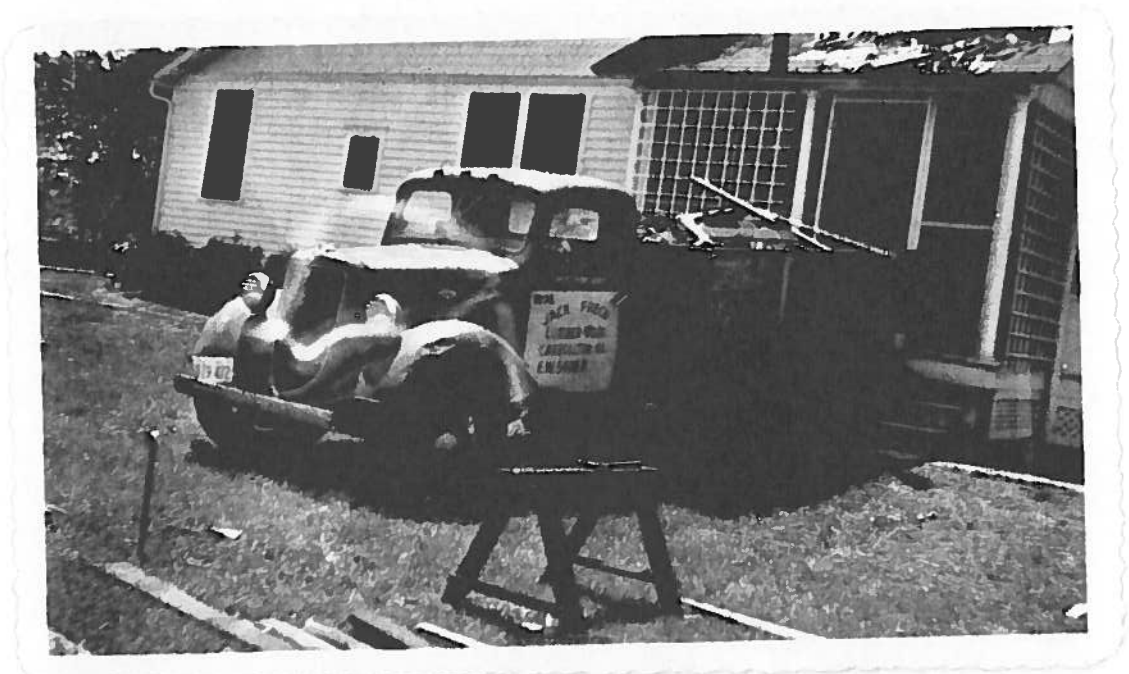
**East side of the house during the repair process after the fire.  
Shows fire debris from the attic being load from above  
the screened in porch south of the rear door of the home.  
Truck belongs to Wm. Jack Frech Lumber-Wood,  
Carrollton, Illinois**

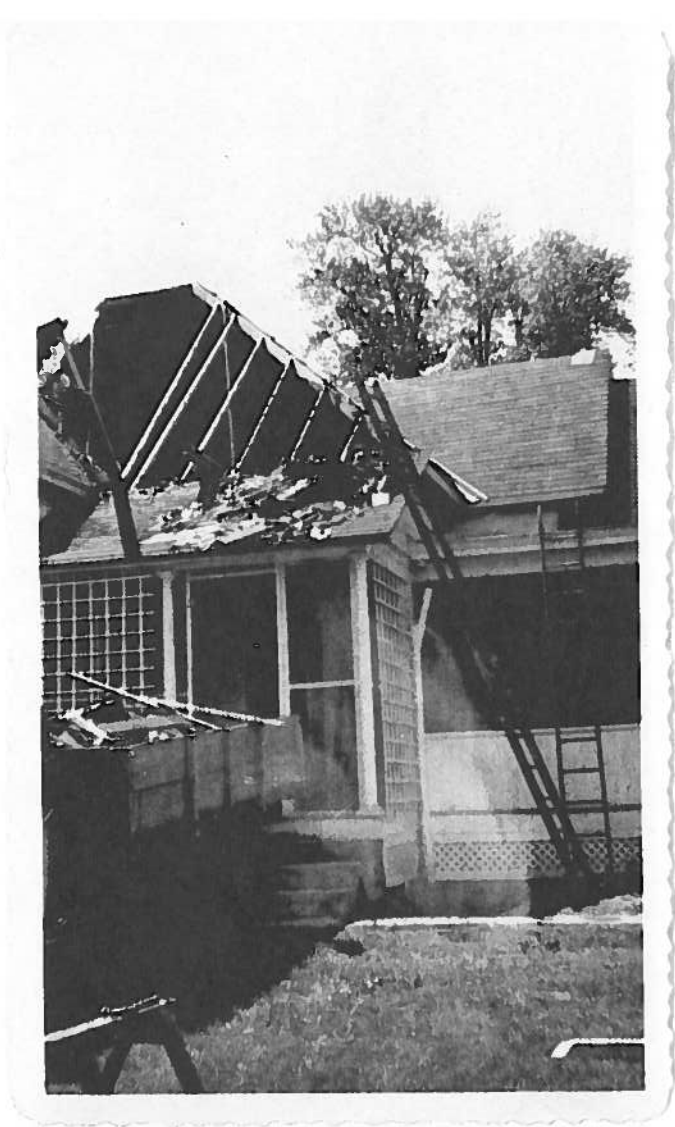
**East side of the house during the repair process after the fire.  
Shows fire debris from the attic being load from above  
the screened in porch south of the rear door of the home.**
